PASSAIC RIVER BASIN
EASTMANS BROOK, MORRIS COUNTY
NEW JERSEY

LAKE PARSIPPANY DAM

NJ 00355

PHASE 1 INSPECTION REPORT
NATIONAL DAM SAFETY PROGRAM.

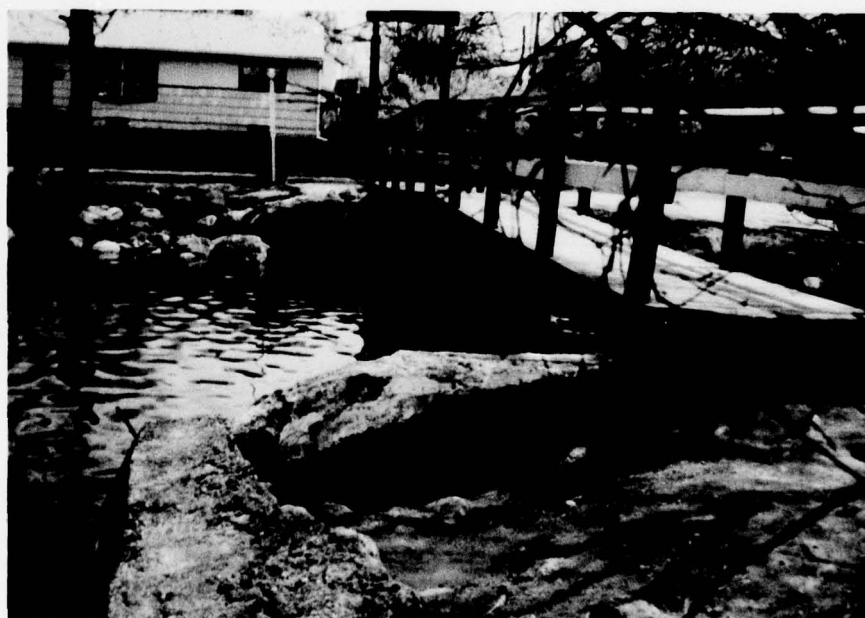
The apron appears to be in structurally sound condition with little or no settlement observed. However, significant spalling was observed on its surface. The timber walkway over the spillway is structurally sound; however, one railing is loose and is considered hazardous. The step-down from the west end of the walkway to the embankment surface is greater than 1 foot and is considered hazardous.

The east wingwall of the spillway is severely spalled over its entire surface and there is evidence of previous patching which now has become deteriorated. The west wingwall is spalled on its downstream end and cracked near the center. The upstream portion of the wingwall is broken off completely and reinforcing rods are protruding. The center pier is spalled on its upstream side from the waterline upward for approximately 1.5 feet. The downstream side of the pier has been patched extensively.

PHOTO 2
DETERIORATION OF CONCRETE AT SPILLWAY

The spillway, wingwalls and apron surface are in deteriorated condition. In the near future they should be thoroughly inspected and renovated by sand blasting, patching, grouting and coating with epoxy.

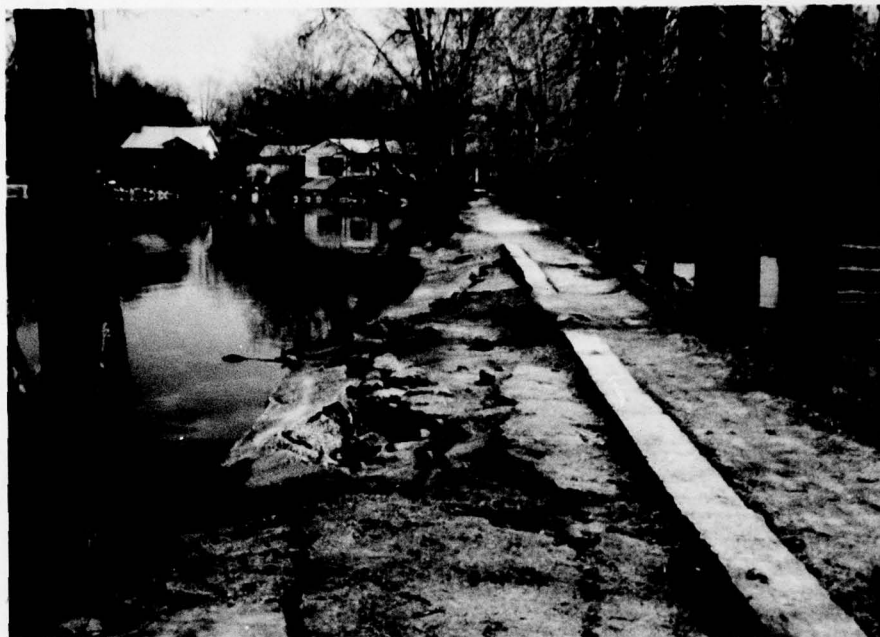
PHOTO 3

The dam embankment appears to be uniformly aligned horizontally with a bend point near the center as shown on the construction drawings. The vertical alignment is irregular with significant depressions noted throughout, most noticeably near the east (spillway) end. The concrete corewall is exposed for about half the length of the dam due to pedestrian traffic and erosion and possibly settlement. The exposed part of the wall does not show any sign of disintegration or spalling. The crest of embankment is bare for most of its length due to pedestrian traffic.

CREST OF DAM - EAST END

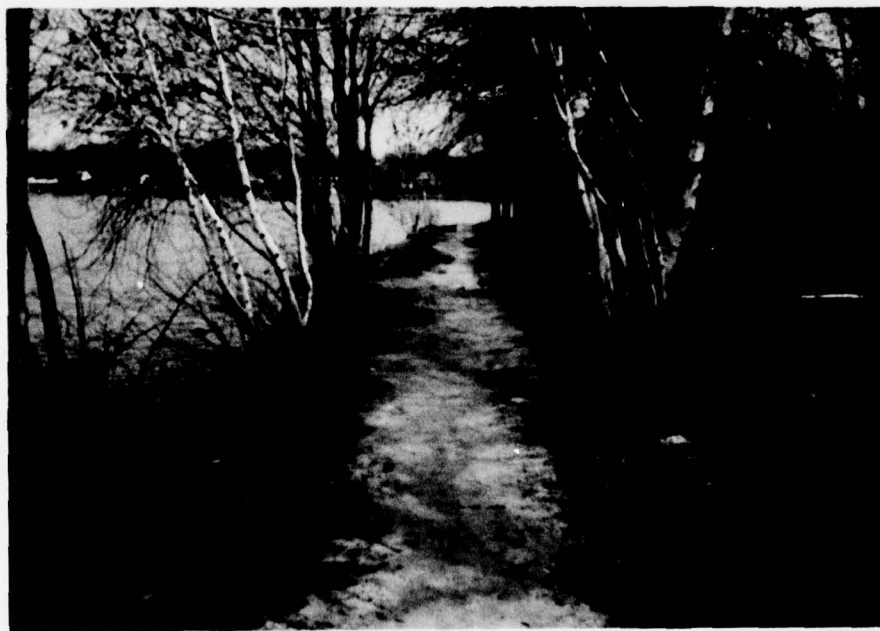
PHOTO 4

CREST OF DAM - WEST END

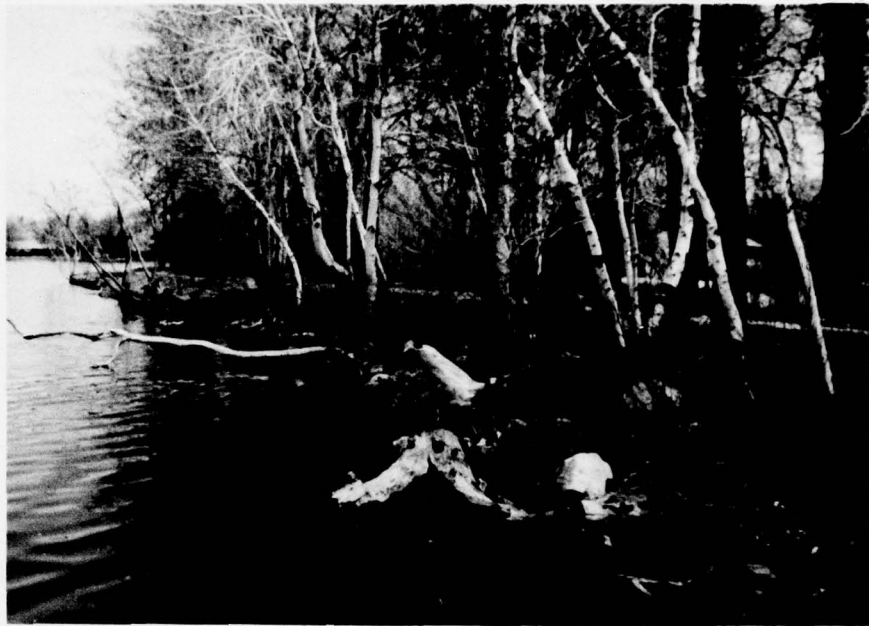
PHOTO 5

Most of the upstream face of dam is covered with riprap. The condition of the riprap appears to be satisfactory below the water line and fair to poor above the water line. In an attempt to protect the riprap, a concrete capping was placed on the upstream slope down to normal pool level. (There is no known record of this repair.) This non-uniform concrete capping is cracked extensively and is generally in a deteriorated condition.

UPSTREAM FACE OF DAM - WEST END

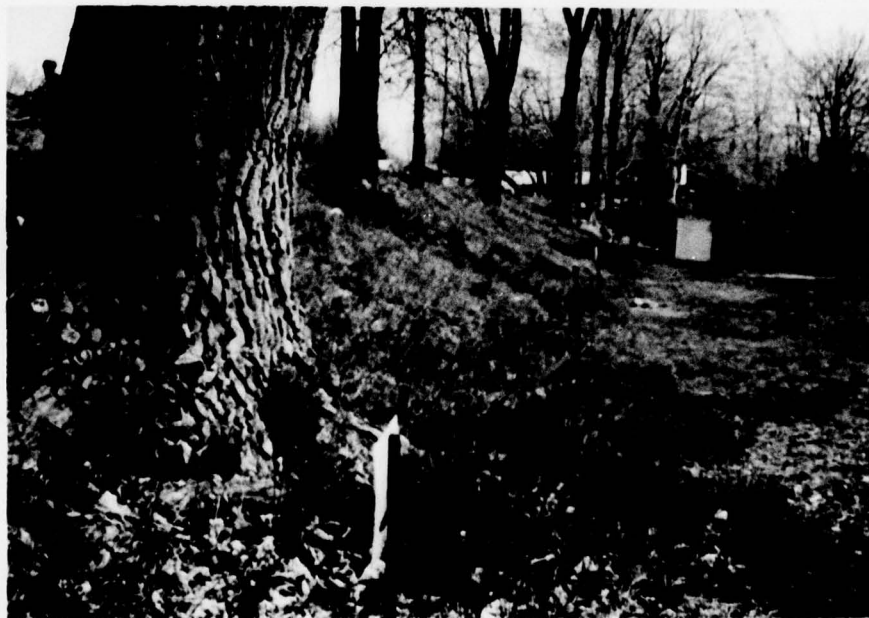
PHOTO 6

Trees and brush are allowed to grow freely on both faces of the embankment. Some of the trees are very large (caliper greater than 24 inches). Grass on the downstream face is generally sparse and eroded to form pedestrian paths except where the downstream face forms the rear of homesites. No evidence of settling or seepage was observed. No animal holes were observed.

DOWNSTREAM FACE OF DAM

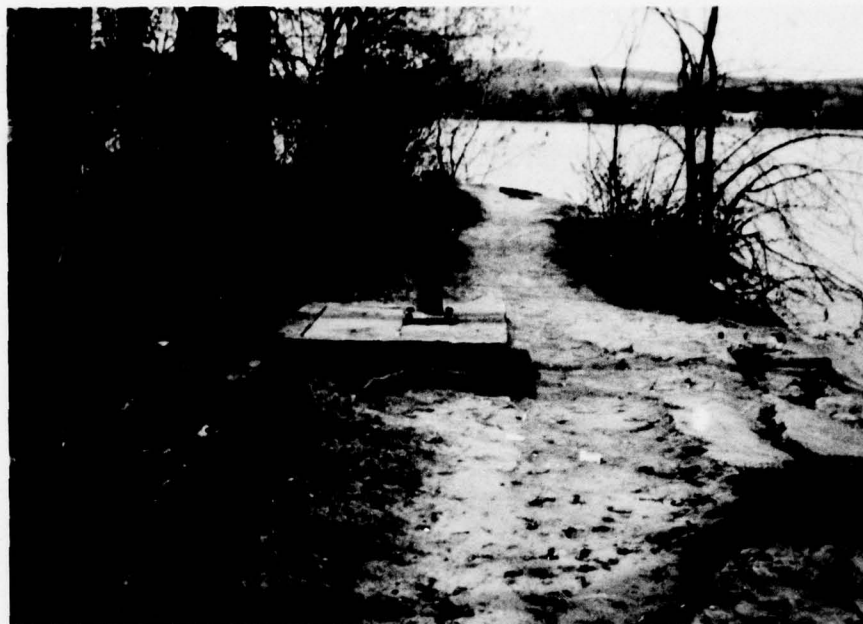
PHOTO 7

OUTLET WORKS OPERATING MECHANISM

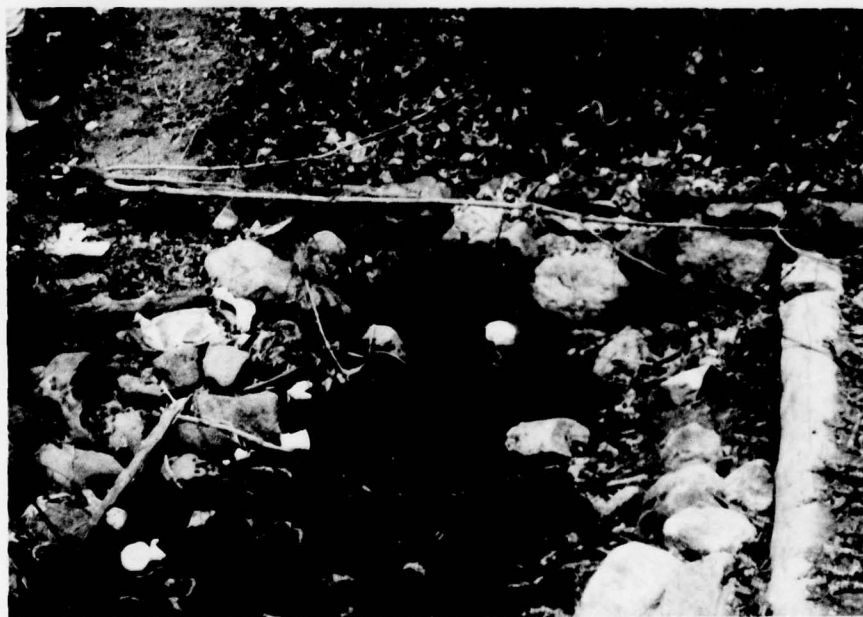
PHOTO 8

The outlet works manhole and the gate operating stem appear to be in good condition. The 24" cast iron pipe could not be observed except at the outlet which was almost totally submerged by tailwater that had very little movement. The grouted stone endwall is in deteriorated condition and the outlet channel is silted and contains accumulated debris.

OUTLET WORKS DISCHARGE PIPE

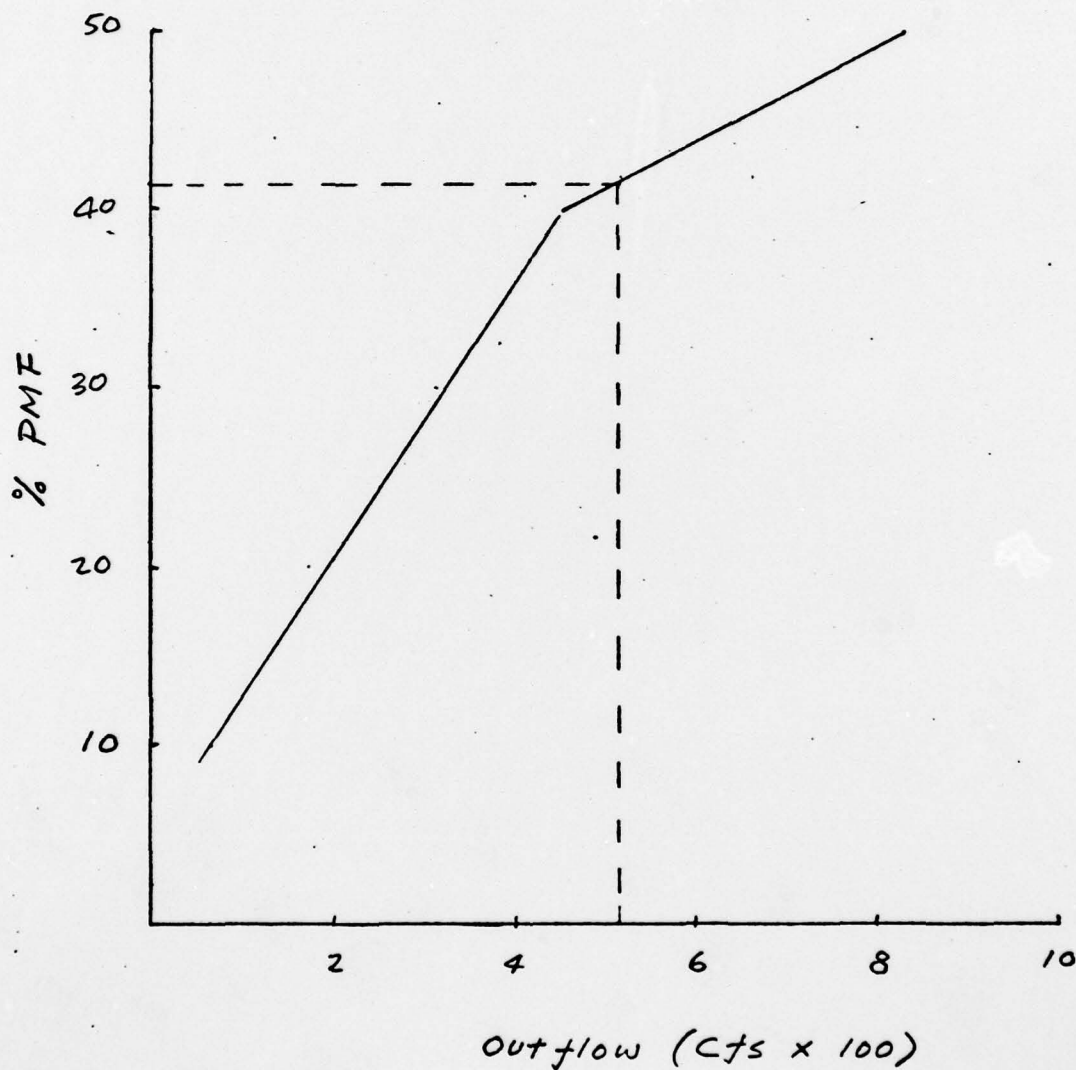
Project Lake Parsippany DamMade By RL Date 5-7-791132 BChkd By Dm? Date 5-16-79Overtopping Potential

Overtopping occurs at elev. 296 with $Q = 514 \text{ cfs}$

\therefore Dam can pass approximately 41.5 % PMF
